**Statement of Significance
for the former North Road
Station, Darlington**

**Archaeo-Environment Ltd
for**

**Darlington Borough
Council**

December 2014

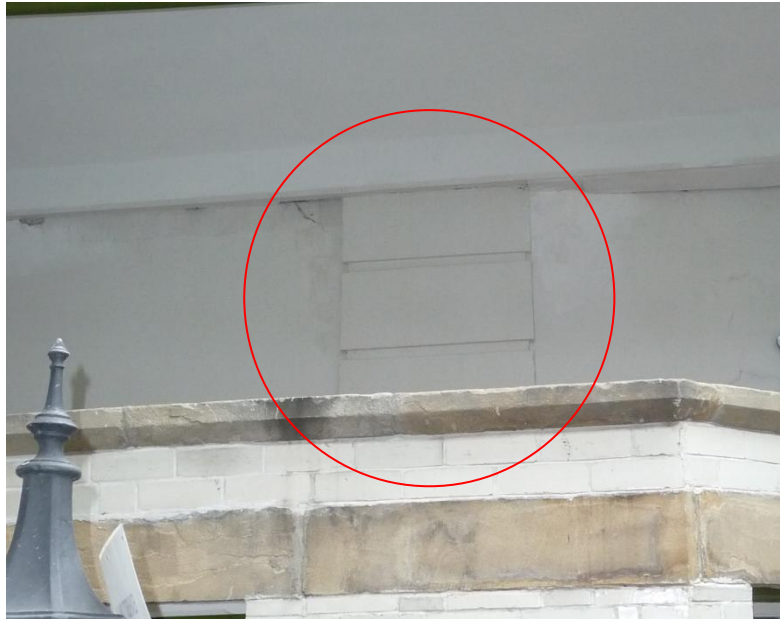
Plate 1. A section of rusticated pier surviving above the attendant's kiosk in the toilets. This is further west than the 1853 piers marked on the OS plan of 1855 so may represent the extent of the 1842 station

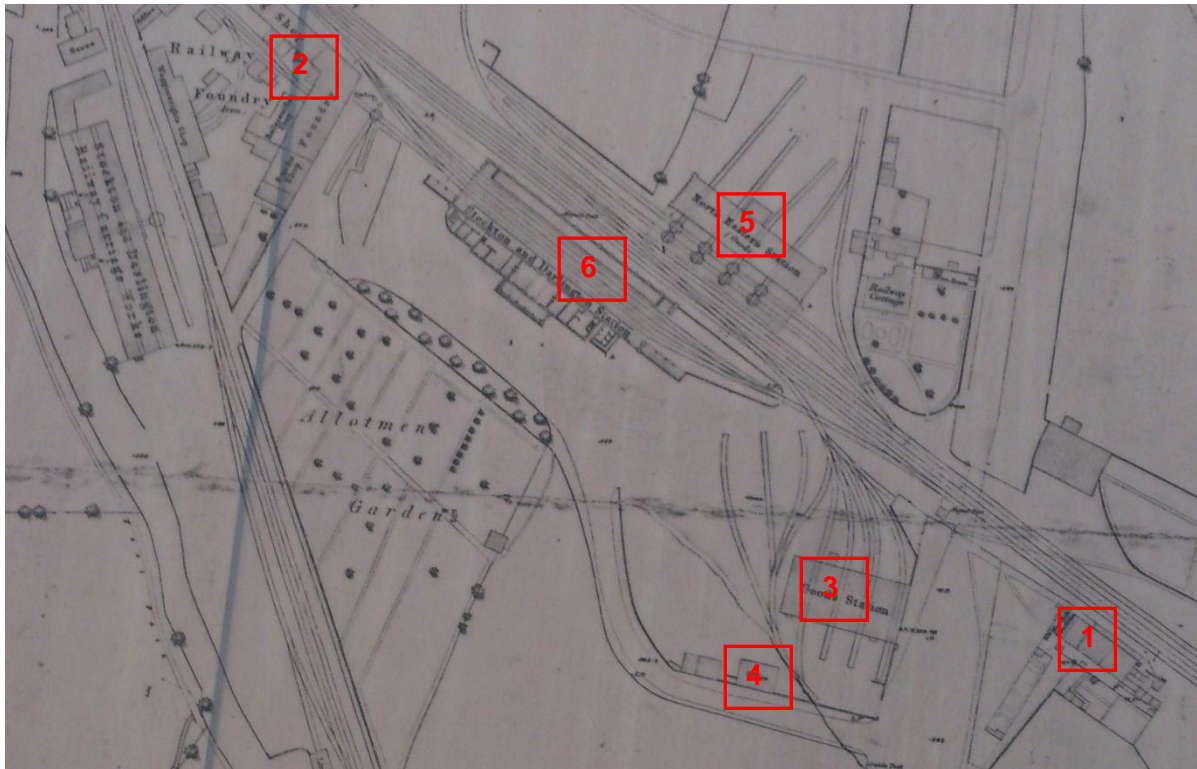
Figure 4. The S&DR station shown on the 1st ed OS map of the 1856 (surveyed 1855) on the south side of the tracks with the North Eastern on the north side. The Goods Station (no.3) and Offices (no.4) on McNay Street are also shown. The original (and first) station can be seen on the east side of North Road (no.1) but is not annotated, presumably because it was now used as cottages for railway staff and their families. Numbering refers to the order of the main railway buildings as constructed. Darlington (North Road) Station is no.6

When the survey took place for the Ordnance Survey 1st edition 25 inch map in 1855 (see fig 5), the station consisted of two platforms and a central siding which joined a further line east of the station which approached the Goods Station from the north with additional sidings to its west. The mapping also showed the extended platforms with lean to sheds supported on columns. The easternmost building was the men's toilets which appeared to be separate from the main station range, but the colour version of the same map suggests that they may have been linked at least by the train shed roof.

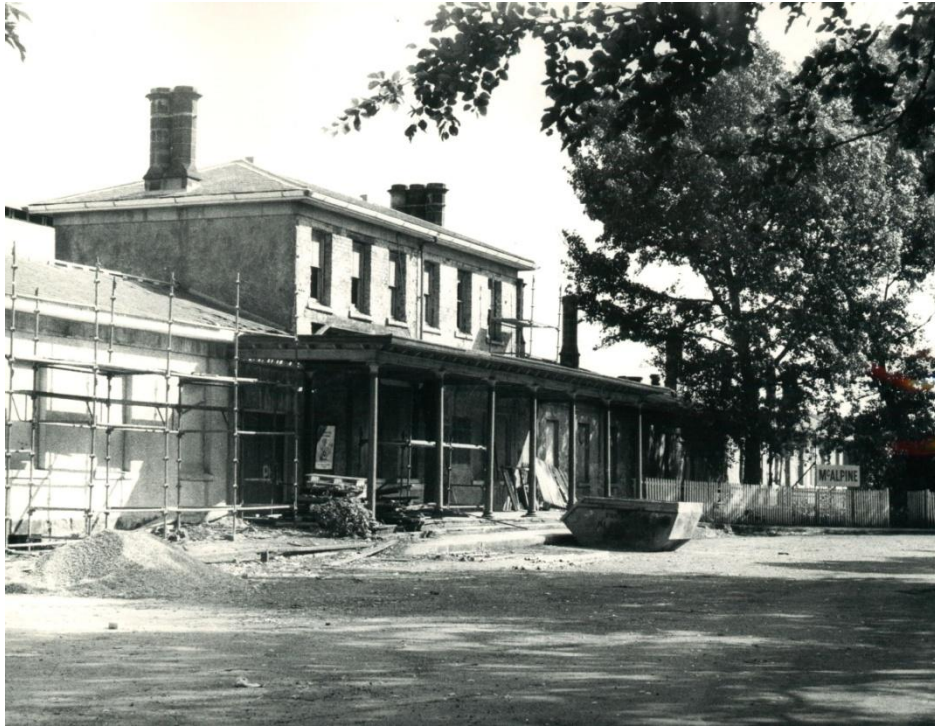
Plate 2. The station during restoration works in 1974. Photo: courtesy of the Centre for Local Studies at Darlington Library.

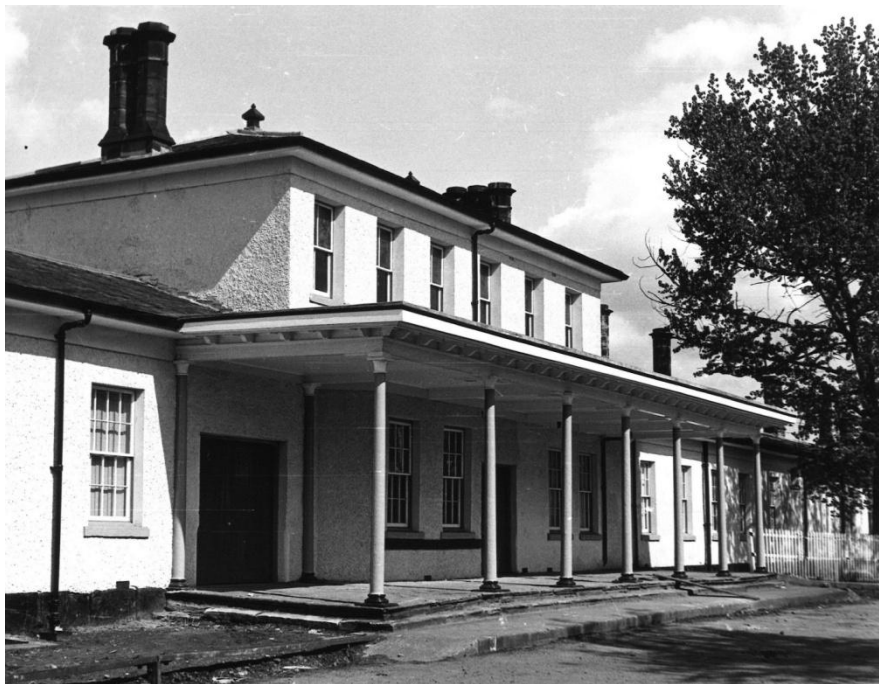
Plate 3. The station nearing the end of its restoration in 1975. Photo: courtesy of the Centre for Local Studies at Darlington Library.

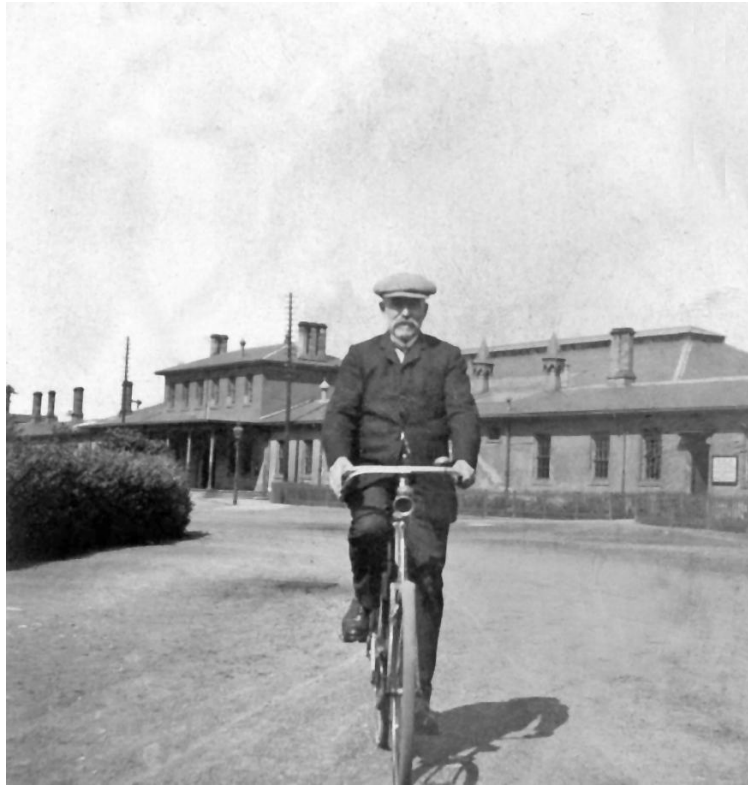
Plate 7. Photo of Brian Wastell's Grandfather leaving work at North Road Station c.1910. Note the decorative vent flues and street lamps. The rough cast appears to be quite a dark colour as opposed to the white today. The flower beds extend up to the portico so the extended ramp that runs along the front elevation on the east side must post-date this photograph. The low level planting also allows the facade to be better appreciated. Towards the back, the train shed roof can be seen. (Photo courtesy of Brian Wastell and made available by Barrie Lamb)

Photographs from the mid 20th century show painted picket fencing around flower beds in front of the south elevation (see plates 2 and 5), but earlier photographs from the turn of the century (see plate 7) show post and wire or net fencing enclosing flower beds which extended all the way to the portico. The extended ramp on the east side of the principal elevation is therefore relatively recent and of less significance. The low level planting allowed a better appreciation of the facade than the present rather unkempt planting.

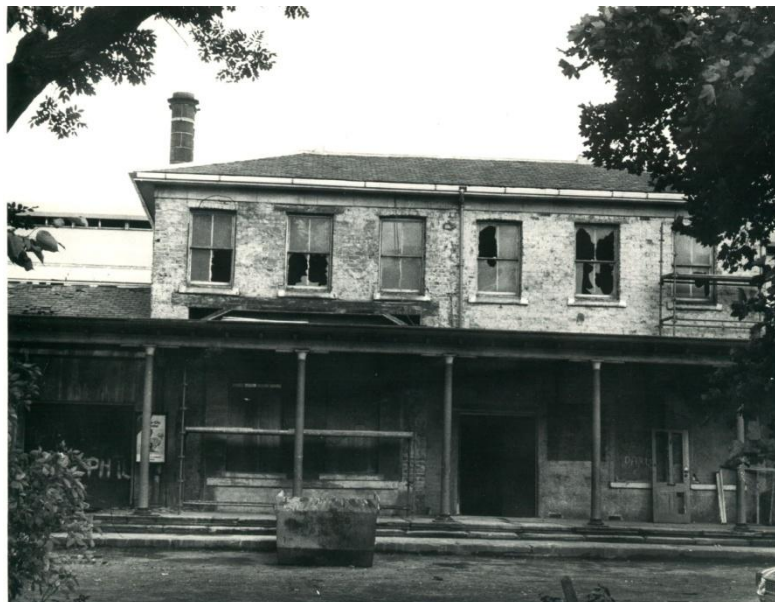
Plate 8. The front elevation during restoration works 1973-4. The upper floors are of brick but the lower ones appear to have been patched in brick, but may have been sandstone rubble originally (photo: courtesy of the Centre for Local Studies at Darlington Library 1761a)

Sowerby's plan (see fig 2) of 1847 shows no bayed window at the front and neither does the 1855 OS plan suggesting that it is a later addition. Interestingly it does not show a separate outside men's toilet block either. The loggia is original and is supported with fine metal pillars topped with simple bowls. The back pillars are slightly embedded in the roughcast, perhaps they were originally more prominent and the roughcast thinner.

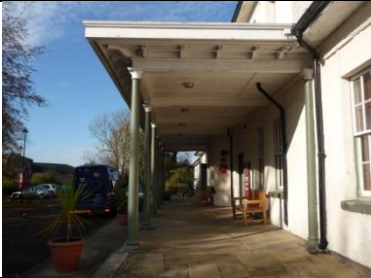
Portico, steps and pillars, wooden corbelling, fascia,	Considerable architectural interest. Leadwork to roof replaced. New paving and added materials to steps and portico surface

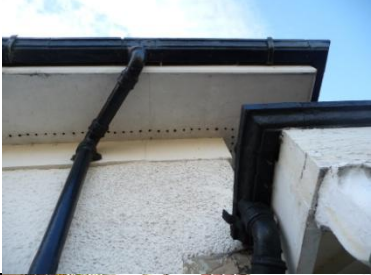
Cast iron rainwater goods	Some may be replacements, but necessary to preserve historic character – some architectural interest

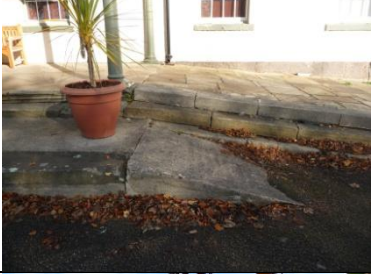
Ramp to east	Limited historic interest. A relatively late addition of the 20 th century to help improve accessibility.

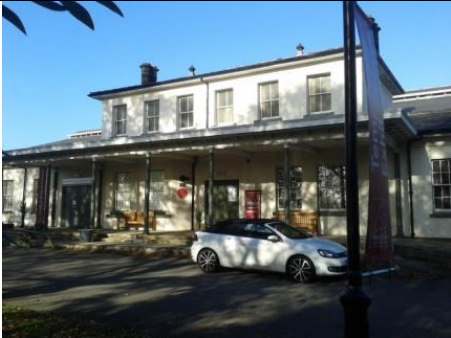
Central 1842 block	Considerable architectural interest as it represents the early styles of the first railway stations in the world; considerable archaeological interest because the changes brought about to this portion will have left evidence beneath the modern render and plaster; considerable historic interest because of its associations with the pioneering and heroic days of the railway

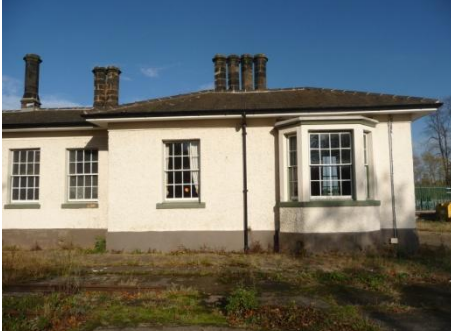
East end 1872	Considerable historic interest as it represents the changing needs of the station to manage goods; some architectural interest because the contractors designed additional offices to reflect the character of the original building.

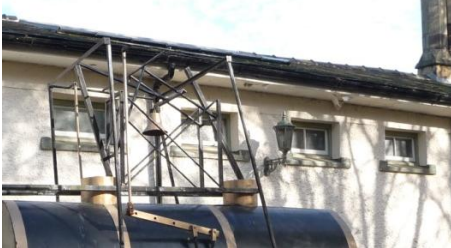
Toilet windows	Negative feature as spoils the harmony of the window style elsewhere on the south elevation, however may be necessary to preserve toilet interiors

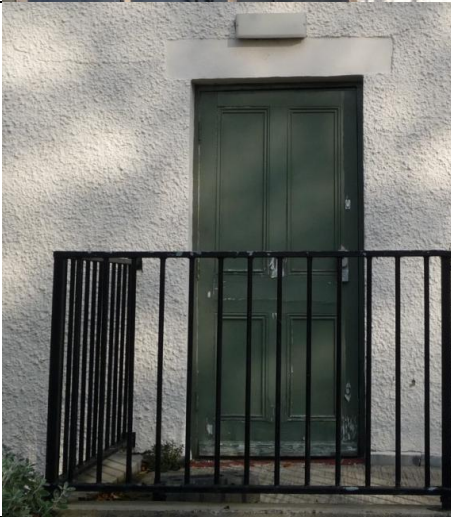
Door to G8	Modern replacement of limited architectural interest because it is a four panel door which reflect the historic character of the rest of the building

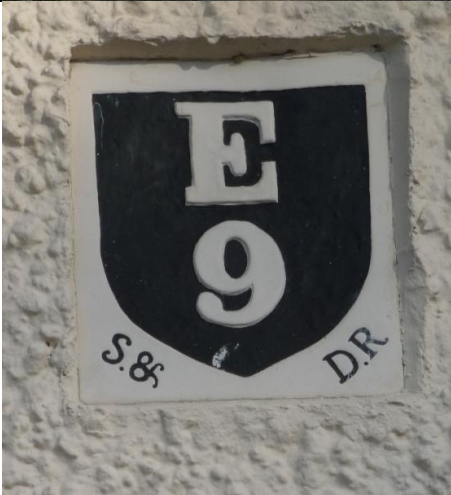
S&DR ceramic wall plaque	Considerable historic interest – standard plaque used on all S&DR properties in the 1850s with a rental value. The letter relates to the line and the number to the property. Very few survive.

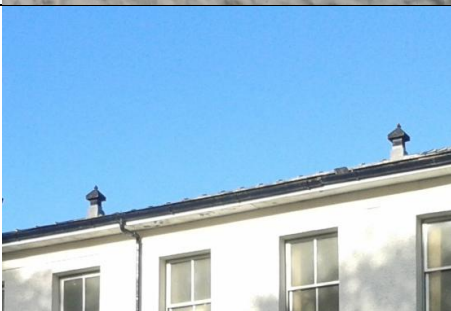
Vents to base and eaves of building and flues to roof	Some architectural interest as important to ensure breathability of interiors and flues to roof were attractive additions which added interest to the roofscape

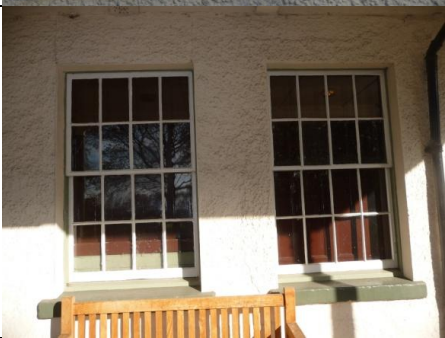
Bay window to front	Some architectural, interest because it introduces some Victorian interest to the elevation; some historic interest as it reflects changes to the layout to improve booking services

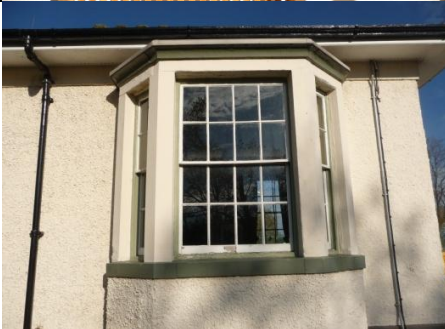
Bay window on east side of 1872	Some architectural interest because it introduces some Victorian interest to the elevation; some historic interest as it reflects changes to the layout to accommodate improved goods services and because it reflects the status of the yard manager. Some archaeological interest because it was reused from G30.

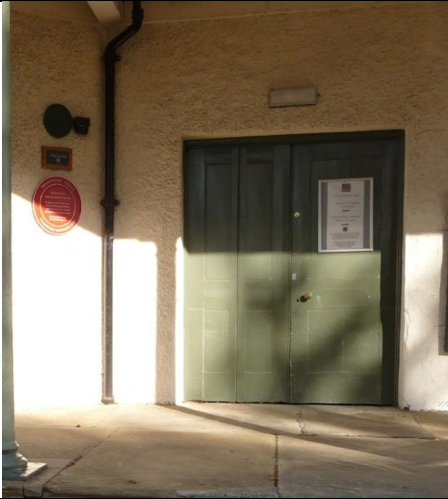
Large entrance doors	Considerable architectural, archaeological and historic interest as they may be original and provide evidence for how the station was used and travellers segregated

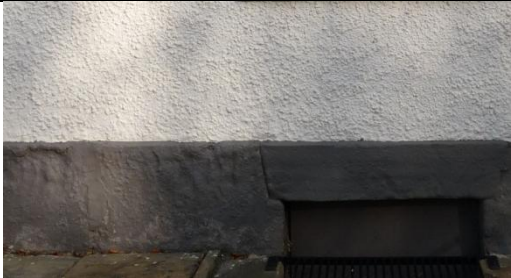
Stylobate	Pulls together the building so that it reads as one build – a typical classical approach to building. Considerable architectural interest

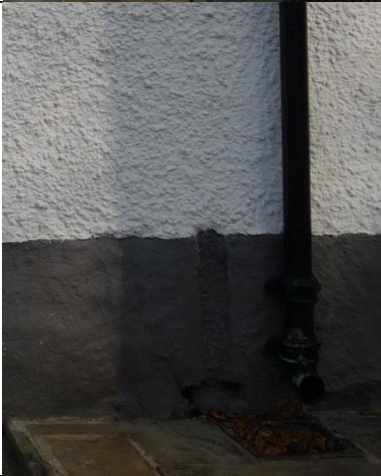
Evidence for earlier fittings on stylobate and in rough cast	Limited archaeological interest – grooves for former drain pipes. Feint evidence of patching of rough cast

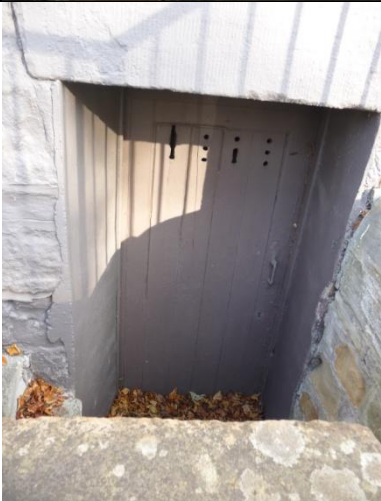
Door and doorway with lintel above and steps to porter's mess	Some historic interest because of its associations with the ghost story, considerable archaeological interest because it appears to have original door (not railings) and leads to the basement which is one of the least altered areas of the original building

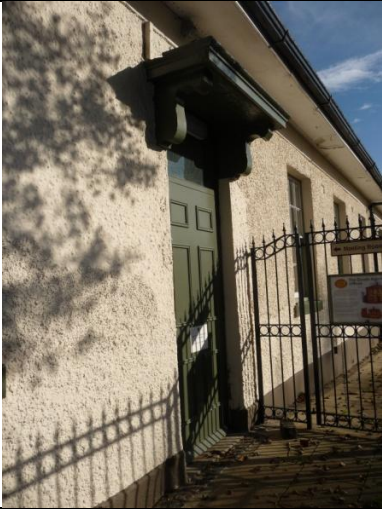
Porch over door into G28 (east end)	Original porch into G28 of some historic interest because it provided a link between yard staff and yard offices without the need to take a longer route around the building

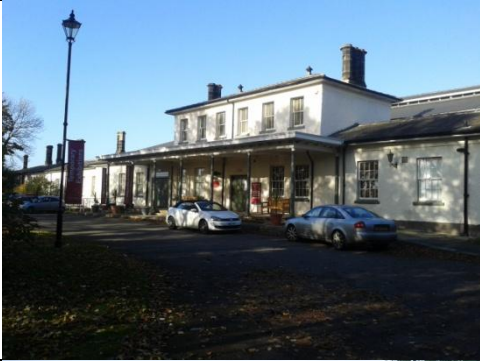
Door into G28 (east end)	Six panels reflecting popular type of door in later extensions to the station – possible a replacement – limited architectural interest	See above	
Views from the approach	Considerable architectural interest , but limited to drive

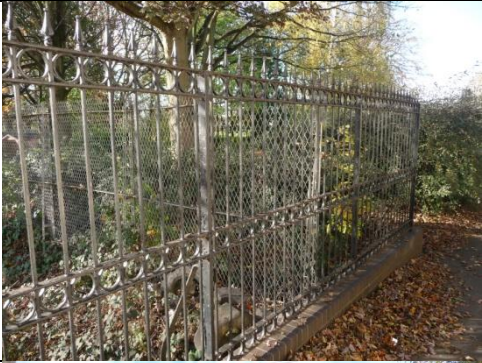
Railings at east end	Modern railings in a style that reflects the historic character of the interiors. Offers a more attractive security option than adjacent security fencing. Limited architectural interest

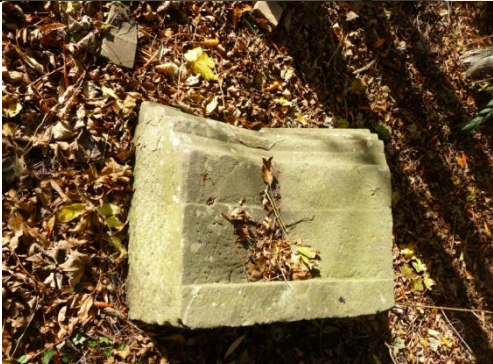
Architectural fragments to frontage	Limited archaeological interest. Ex situ fragments which can help to throw light on earlier building remains, but not labelled and so significance not easily understood by visitors. Some fragments in a neo Gothic style may be from the now demolished prudential building on High Row (Barrie Lamb pers comm.)

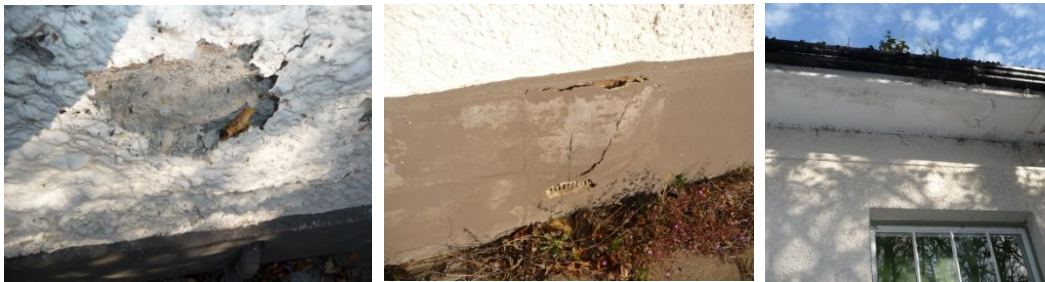
Plate 10. Left: Cracks in cementitious render are caused by lack of breathable materials and lack of maintenance. Such damage leads to damp internally and damage to stone or brickwork beneath. Centre: non breathable paintwork and cementitious coatings to the stylobate have resulted in decaying stonework behind. In this instance an air vent has also been cemented over. Right: vegetation is growing out of gutters which needs to be cleared before resulting in expensive damage and further water ingress

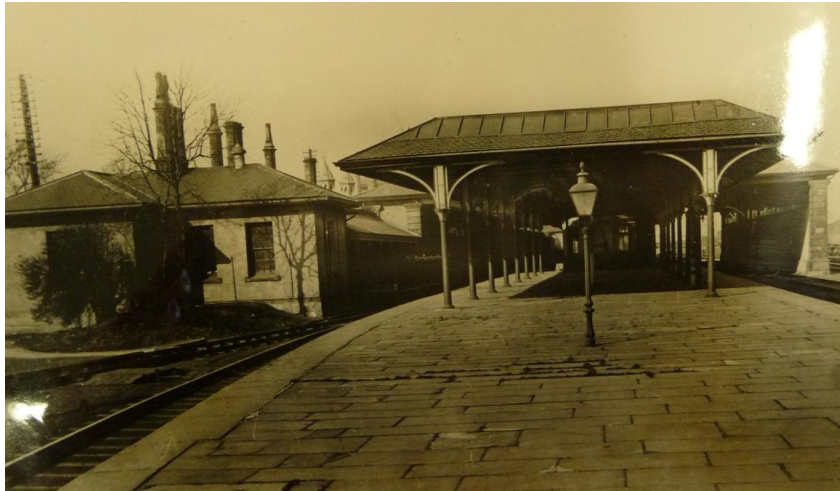
Plate 11. Photo of the east end with a much extended train shed supported on iron columns. This extended shed was designed by Peachey in 1864 and demolished in 1932¹⁶

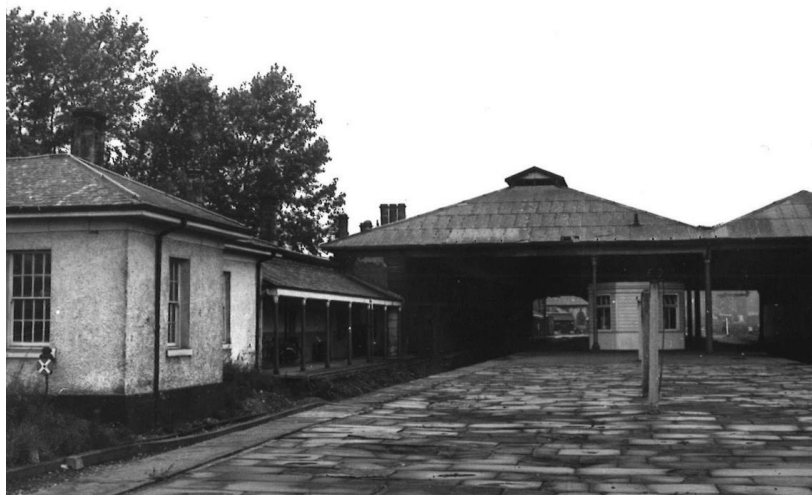
Plate 12. East elevation c.1969 (Centre for Local Studies at Darlington Library)

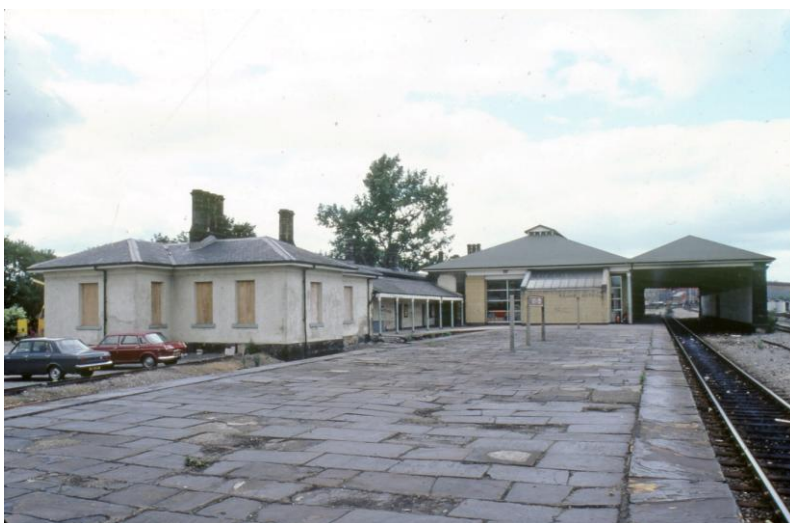
Plate 13. East elevation during restoration 1974 (Beamish Living Museum of the North)

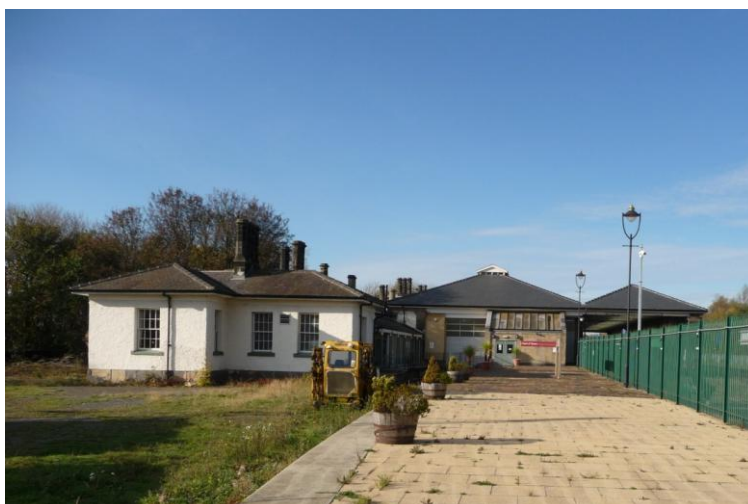
Plate 14. East elevation in 2014

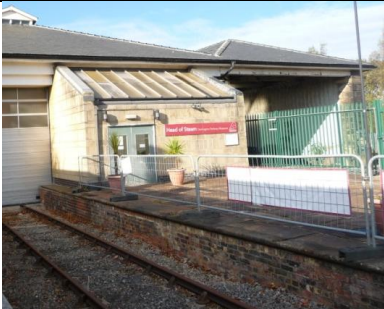
Island platform 1857 onwards	Some archaeological interest, limited architectural interest – brickwork appears early, but island platform was extended and widened. The surface is renewed

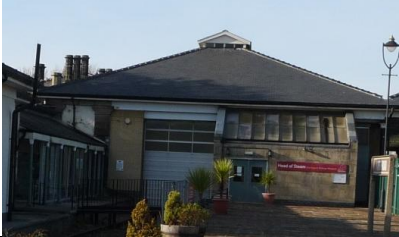
Main train shed roof with glazing product of extensions of 1853 but with replacement materials	Considerable historic and some architectural interest

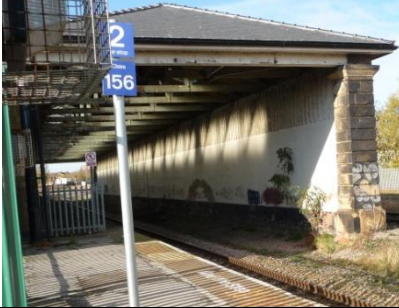
1860 train shed	Considerable historic interest and some architectural interest

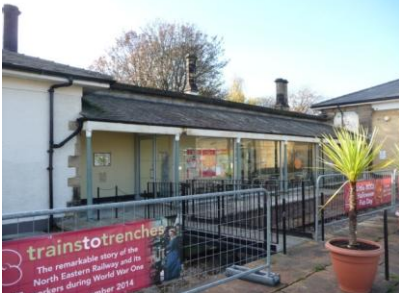
Security fencing and temporary security barriers	Negative features

While the station is undoubtedly in better condition that it was in 1973, the solid end walls and green security fencing make it difficult to appreciate the running of the station and less visually obstructive methods of exclusion would enhance the appearance of the station.

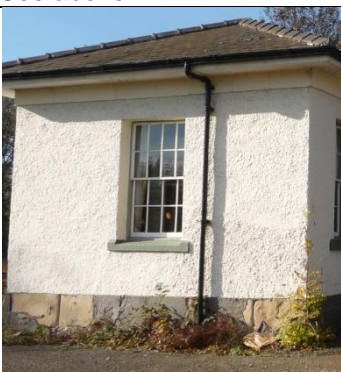
Stylobate 1872	Considerable architectural interest for the unifying effect on the building, but in poor condition

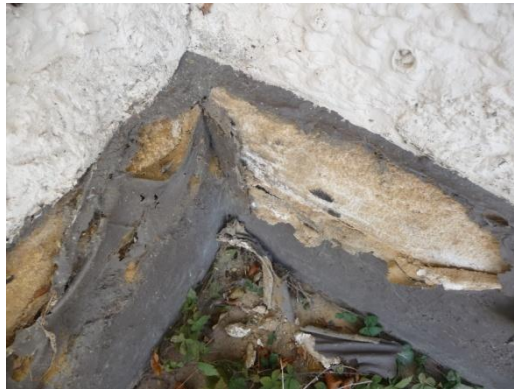
Plate 15. Paint is peeling off the sandstone stylobate and the stone is disintegrating beneath

them with a lime render that allows the building to breathe and moisture escape into the open.

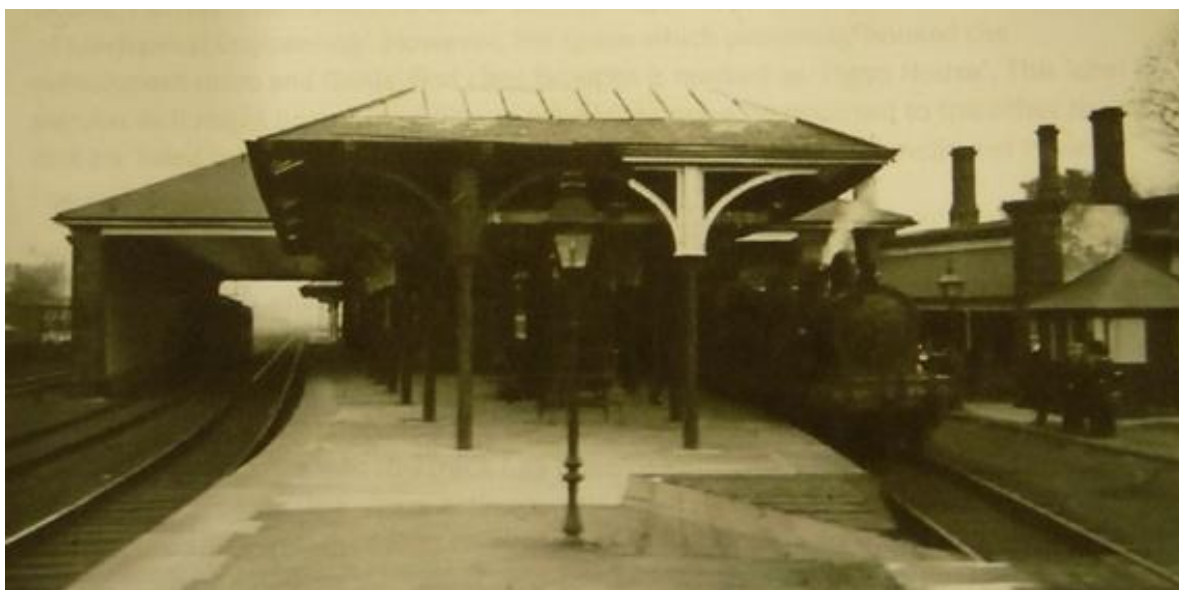
Plate 16. Looking towards the train shed from the west c.1908. Peachey's verandas are still in place in this photo but were removed in 1932. The small building adjacent to the rusticated stone pillars was the timekeeper's hut. This has also been demolished.

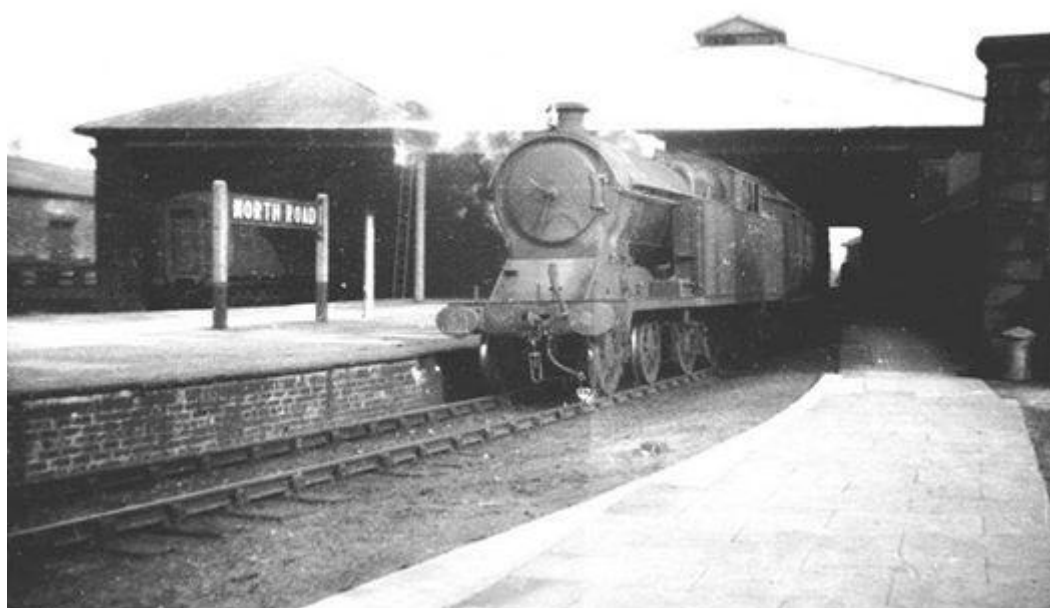
Plate 17. Photo depicts the same surface materials used on the platform today.

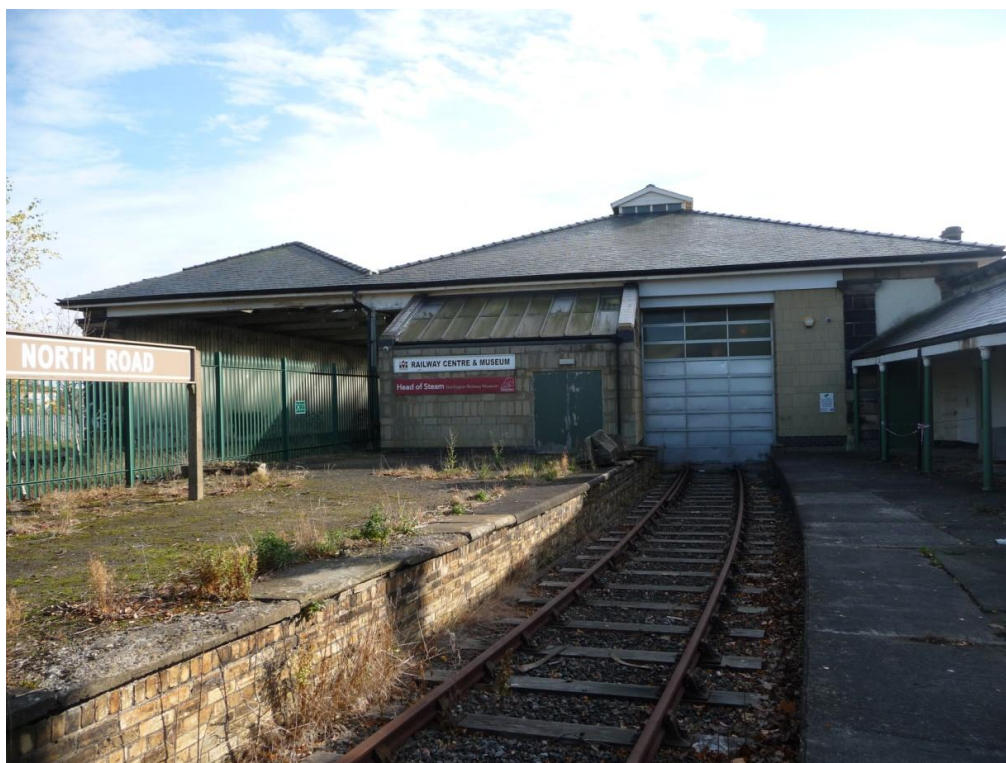
Plate 18. The same view in 2014. The platforms are intact, the renewed shed roofs appear to be in good condition, but the blocking to the train shed has lost any visual permeability that the original train shed had

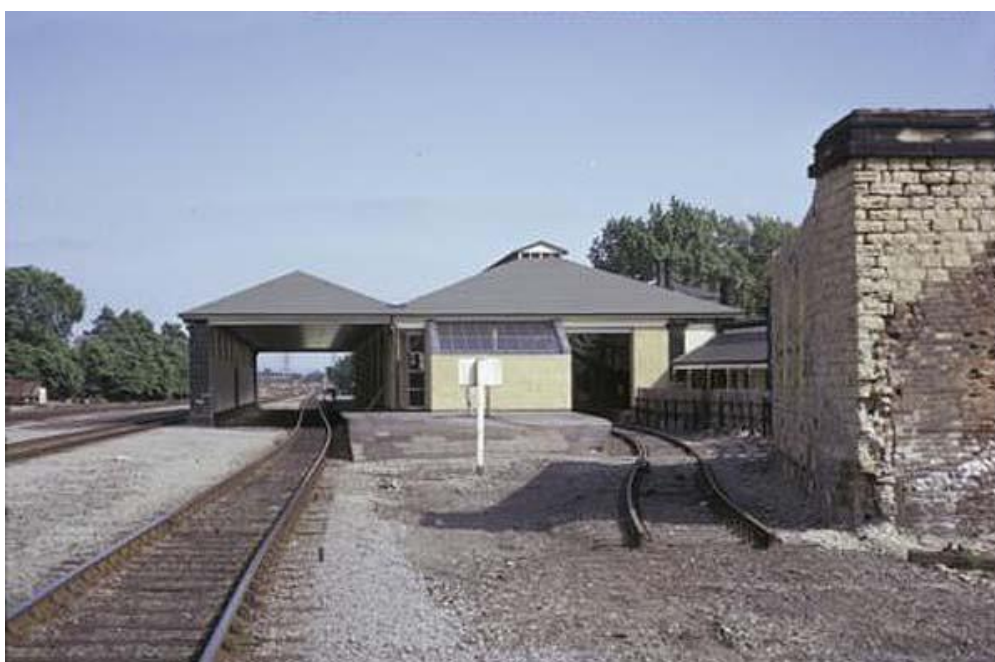
Plate 19. This photo was taken in 1975. The stone building on the right looks like the remains of Kitching's Iron Foundry which tragically appears to have been demolished after 1975. This building was largely intact ten years earlier (based on historic photos not reproduced)¹⁷

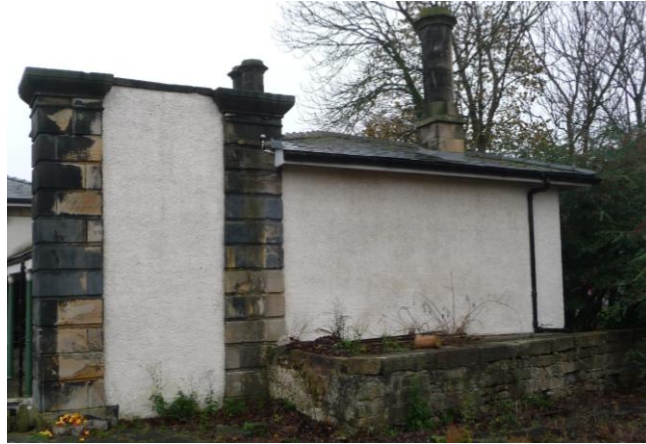
Plate 20. Scarring on the sandstone pier marks where the timekeepers hut stood. The stone foundations are what is left of the ashes store.

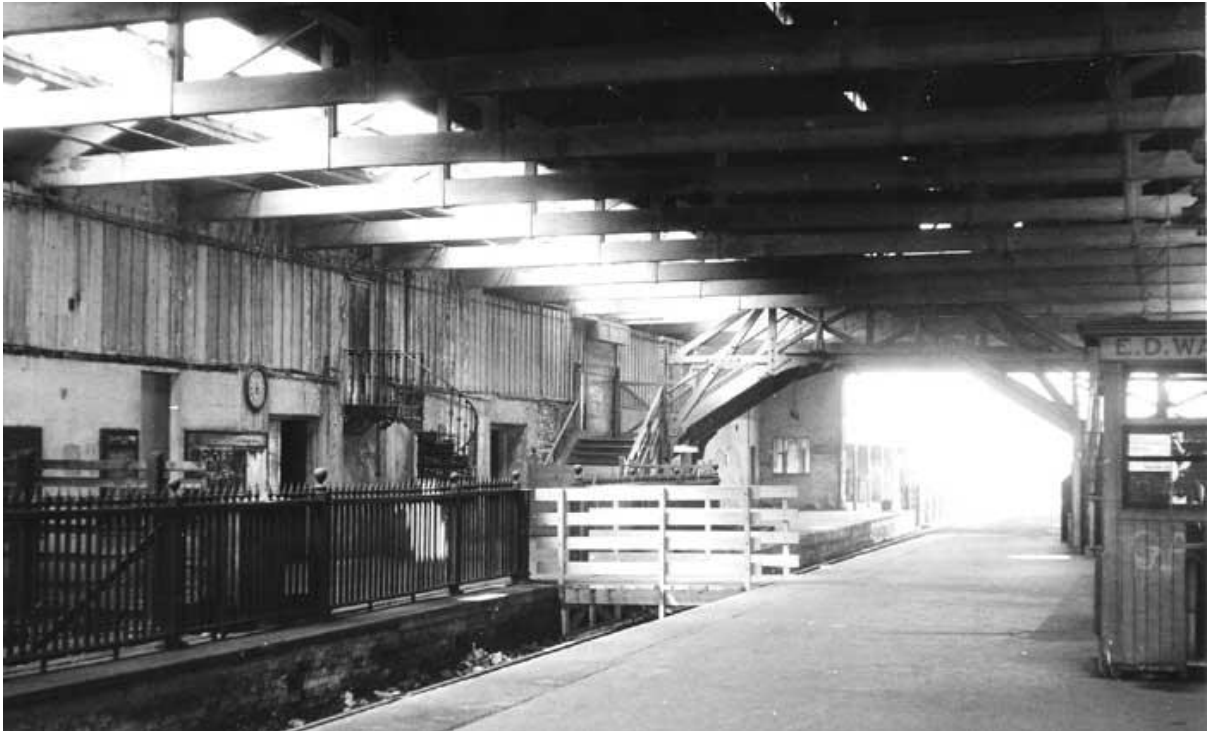
Plate 22. Train shed interior with the north elevation on the left looking towards the ticket office entrance and clock and spiral staircase dating to 1876 when the upper floor was added. The upper floor appears to be clad in timber.

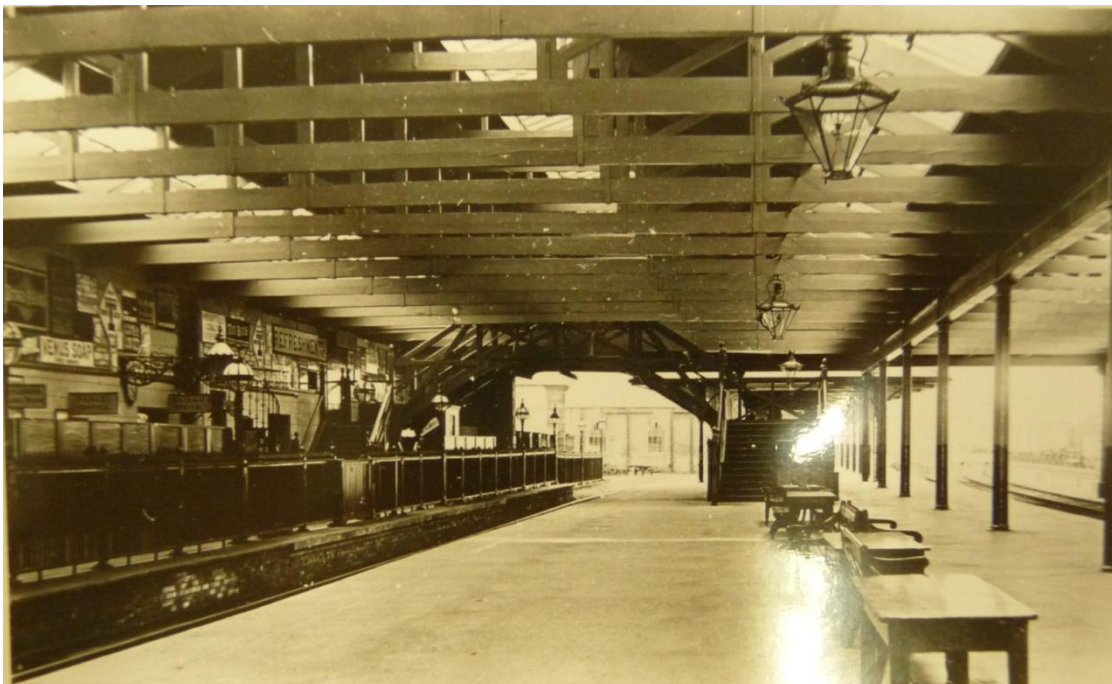
Plate 23. Photo dating to 1925 showing the north elevation covered in adverts and a large sign above the stair door for Refreshments. Signs at right angles to the doors displayed the functions of each room – much as they do today in the museum.

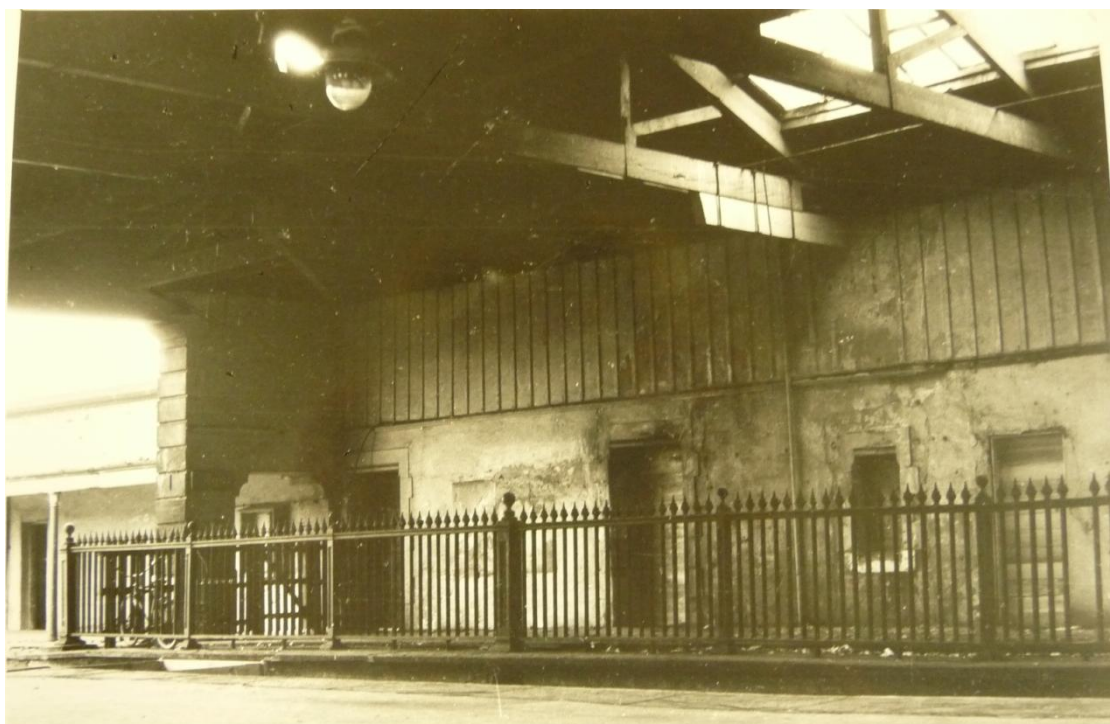
Plate 24. The derelict station in 1968 facing the north elevation on the east side with (left to right) rooms G24, G22 and the attendant's kiosk window and G21 into the cellar. Railings were added by the NER (Fawcett 2001, 133)

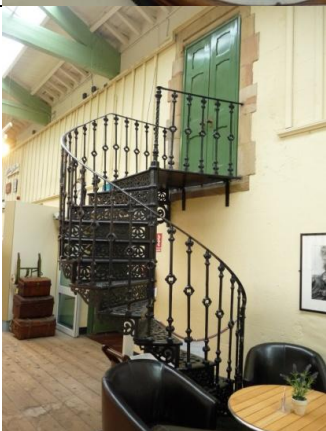
Spiral staircase	Considerable architectural interest. Presumably commissioned by Renshaw and Walker as they built the first floor. May have also been overseen by William Peachey. Regularly features in historic photographs so limited artistic interest

Most children like to climb on board the trains, but here they are not permitted and signs ask visitors not to climb on the 'displays'. Children (and adults) also like to climb up the spiral stairs. Subject to safety checks, bringing the stairs back into use would not be harmful.

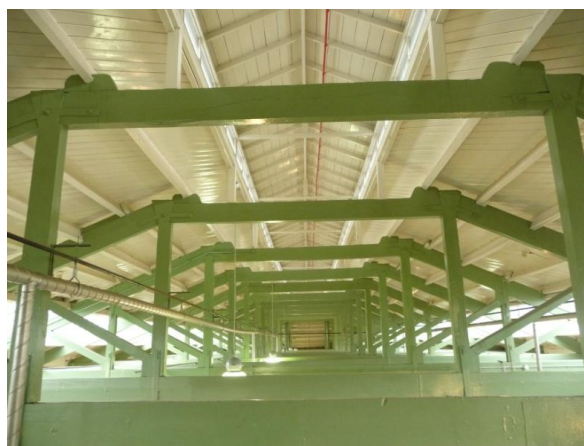
Plate 25. The original 1842 Queen post trusses

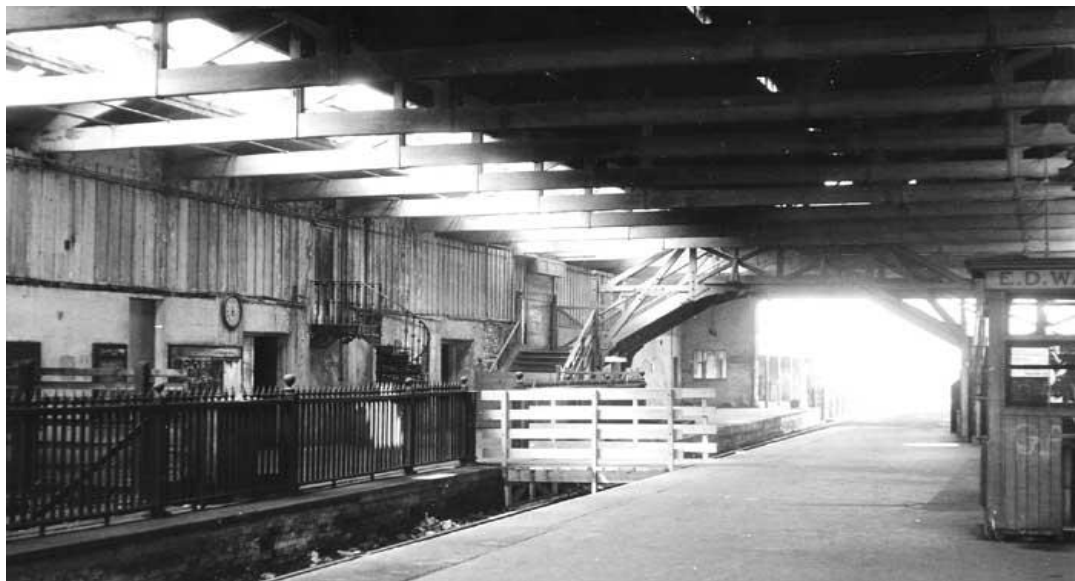
Plate 6. The station interior, looking west, in the early 1970's. By then North Road had been reduced to a halt. We see the wooden footbridge which the NER provided after linking through the two bays to provide another through line; BR had no need of this second line and therefore substituted level access. The footbridge and the kiosk on the right still feature in the present museum²⁰ as does the clock, the spiral staircase and the railings.

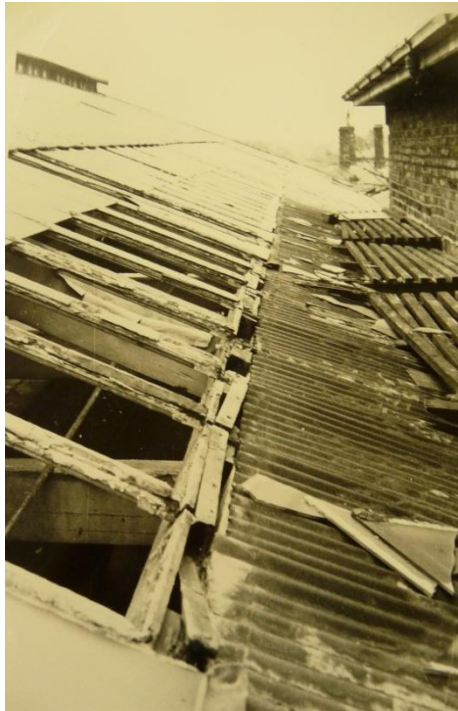
Plate 26. The train shed roof at the join with the upper storey of the station before restoration

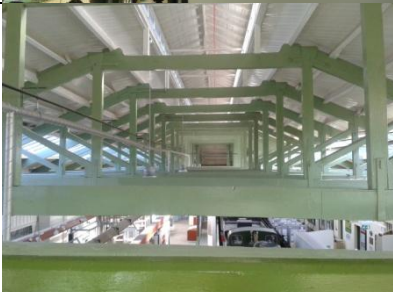
Queen post trusses (1842)	Considerable architectural interest

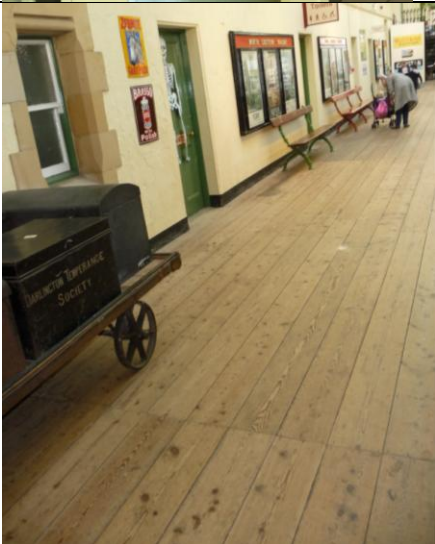
Island platform 1857, extended or replaced 1864	Appears to have been resurfaced, lengthened and widened. Modern brickwork has been used – no evidence of soot. Considerable signs of effervescence. Limited archaeological interest, some historic interest

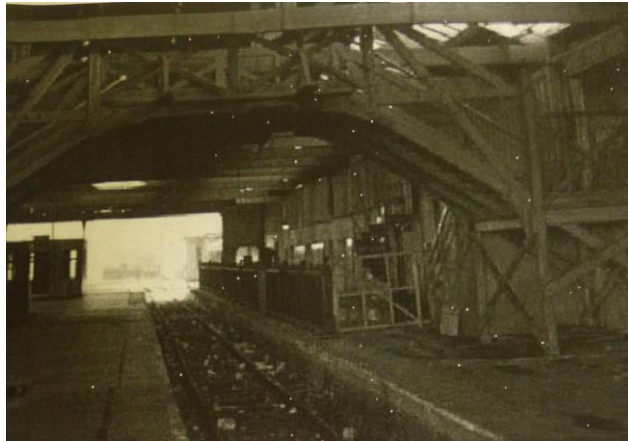
Plate 27. Train shed interior looking east in 1973. This shows how the train shed has come a long way since the station closed. The footbridge looks like it needs support and in the distance is the waiting room and the NER railings

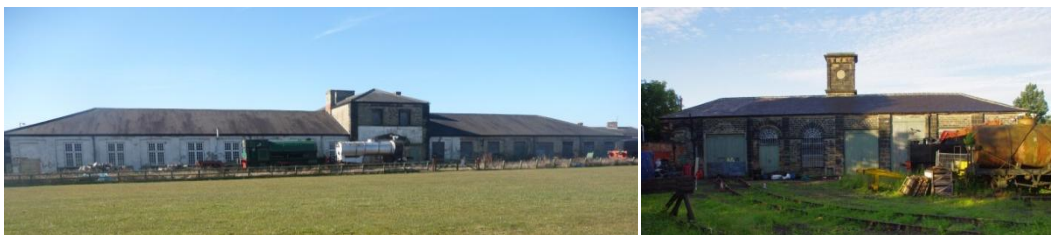
Plate 8. Hopetown Carriage Repair Shops (left) and the Goods Shed (right)
